# Portage Creek Sediment Remediation Project Kalamazoo, Michigan

Pre-Sediment Removal Structure Feature Assessment  
Removal Areas SA3-A, SA3-B and SA3-Access

F&V Project Number: 809930

August, 2012

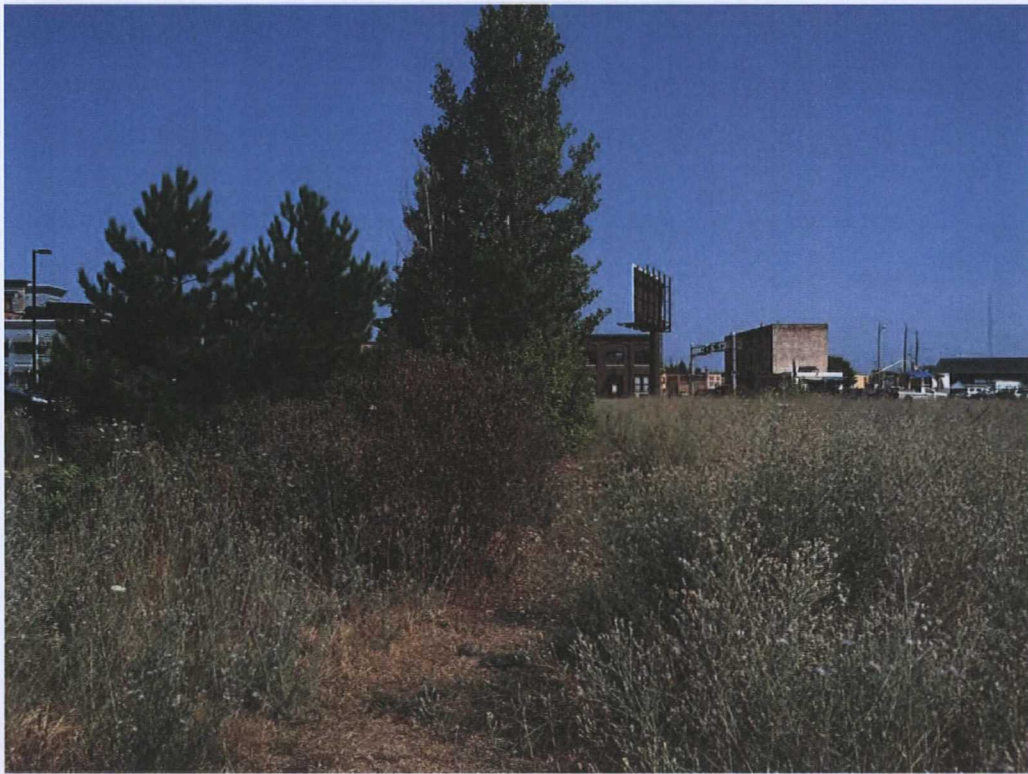
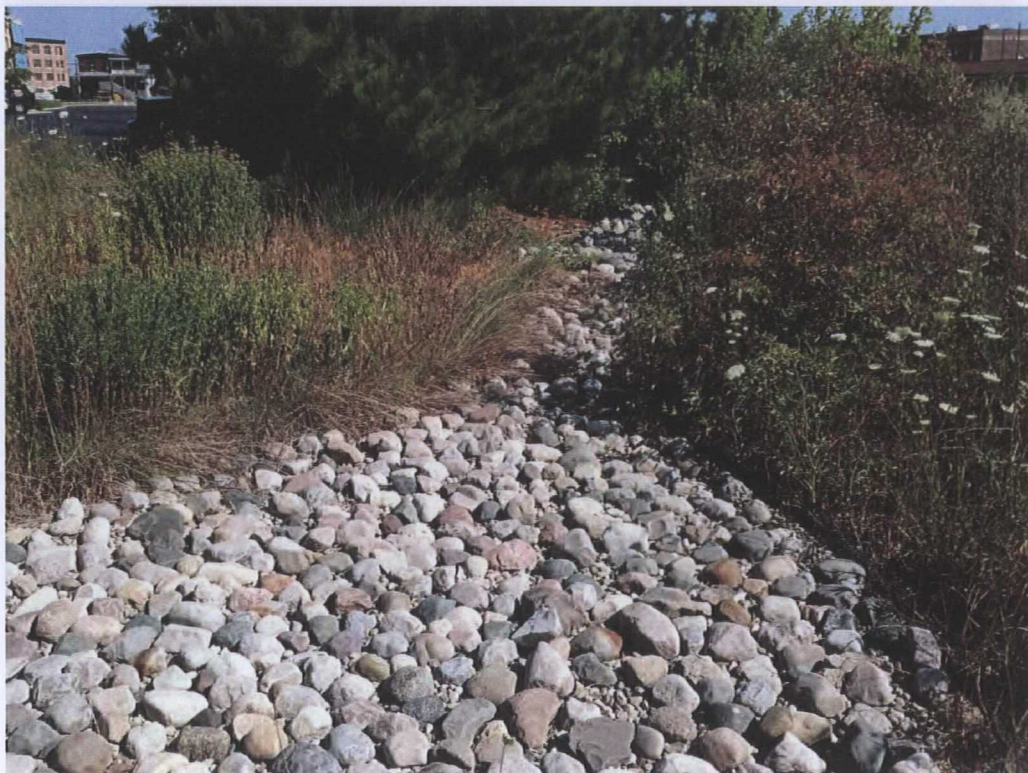
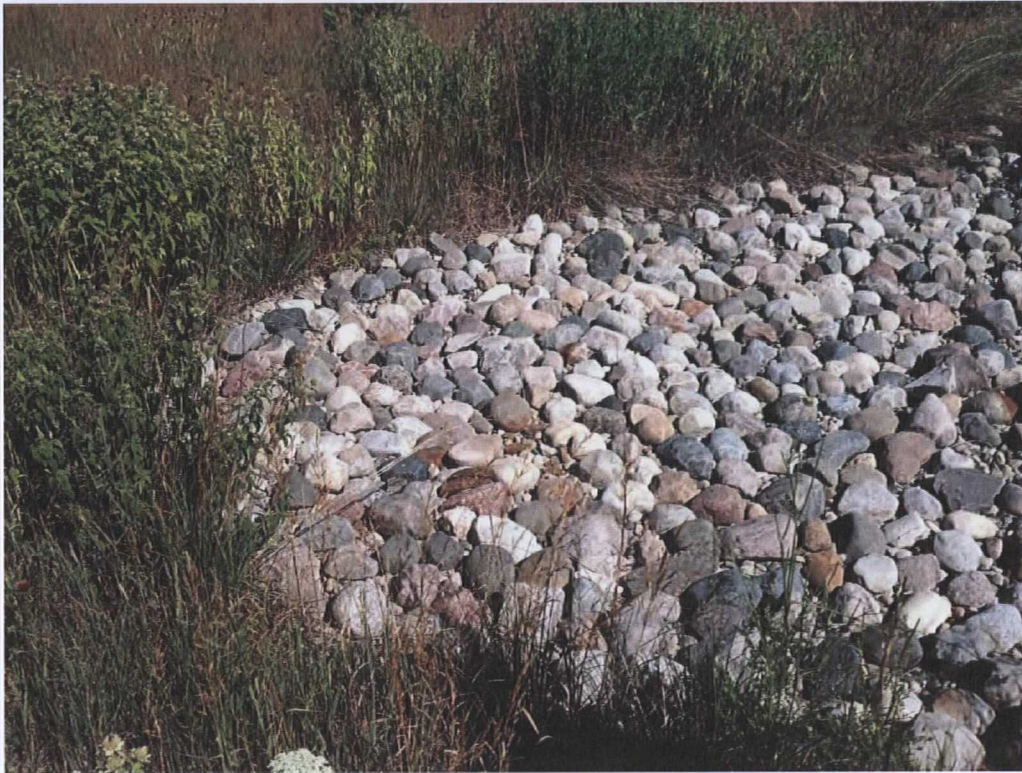
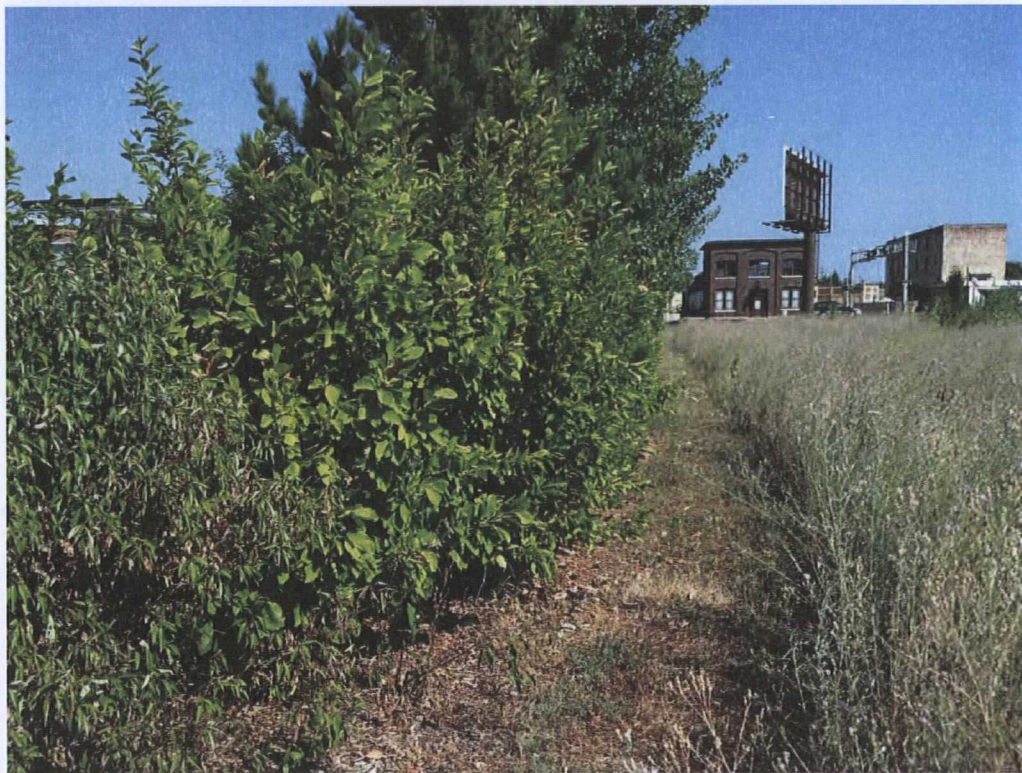
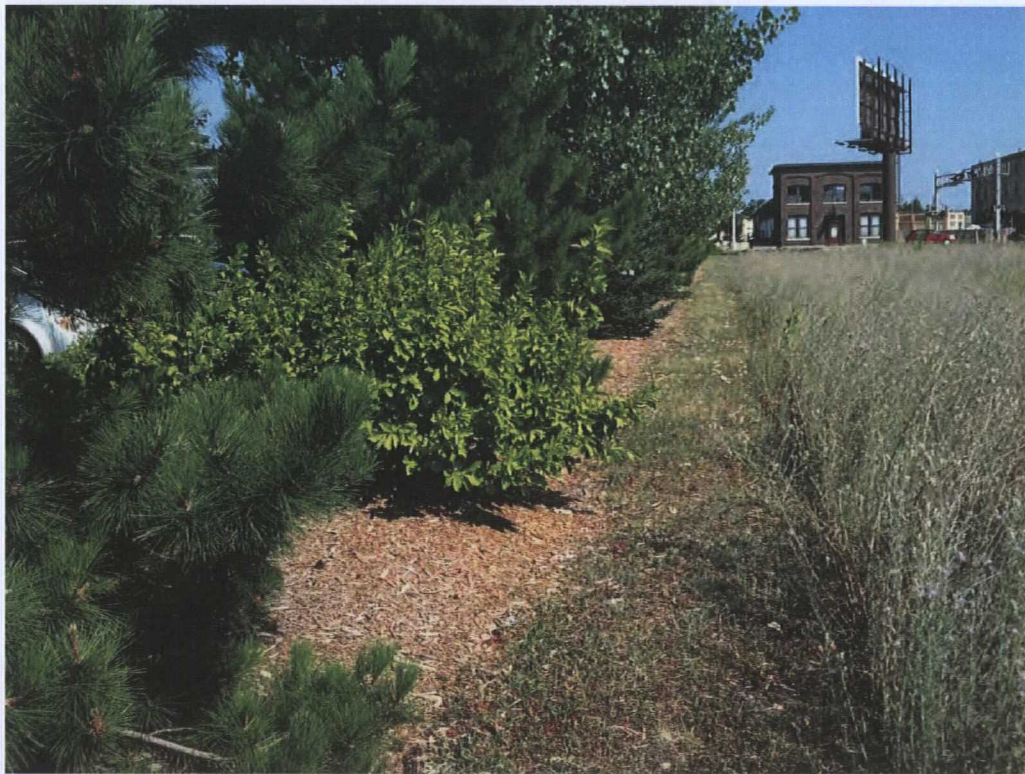
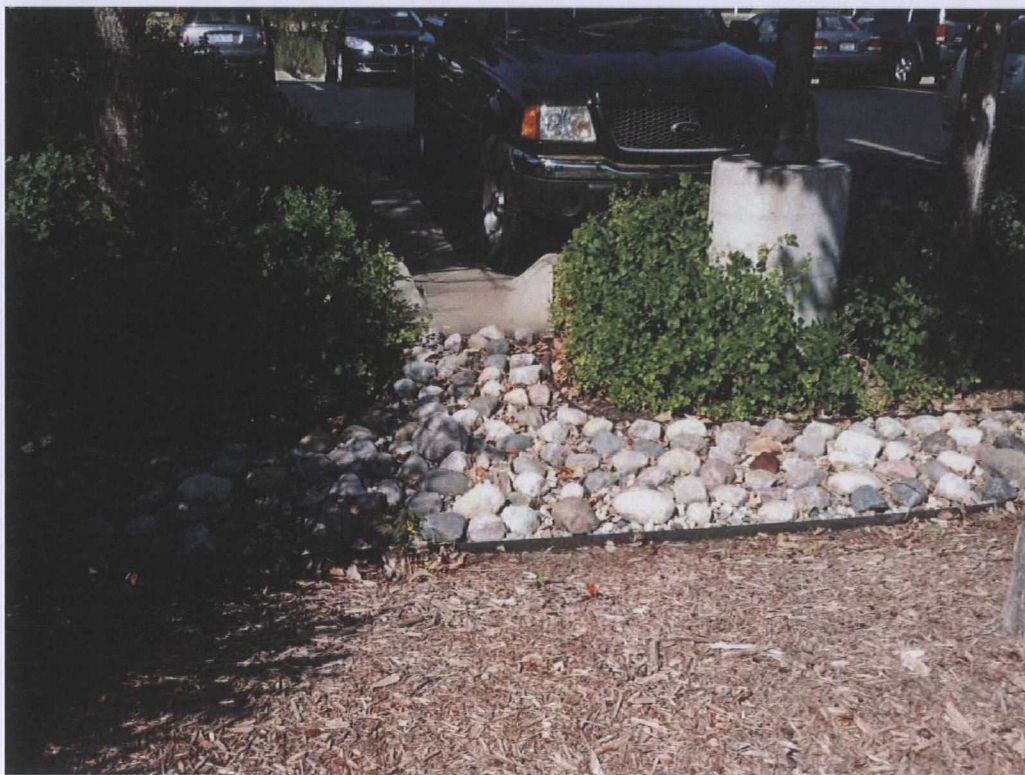
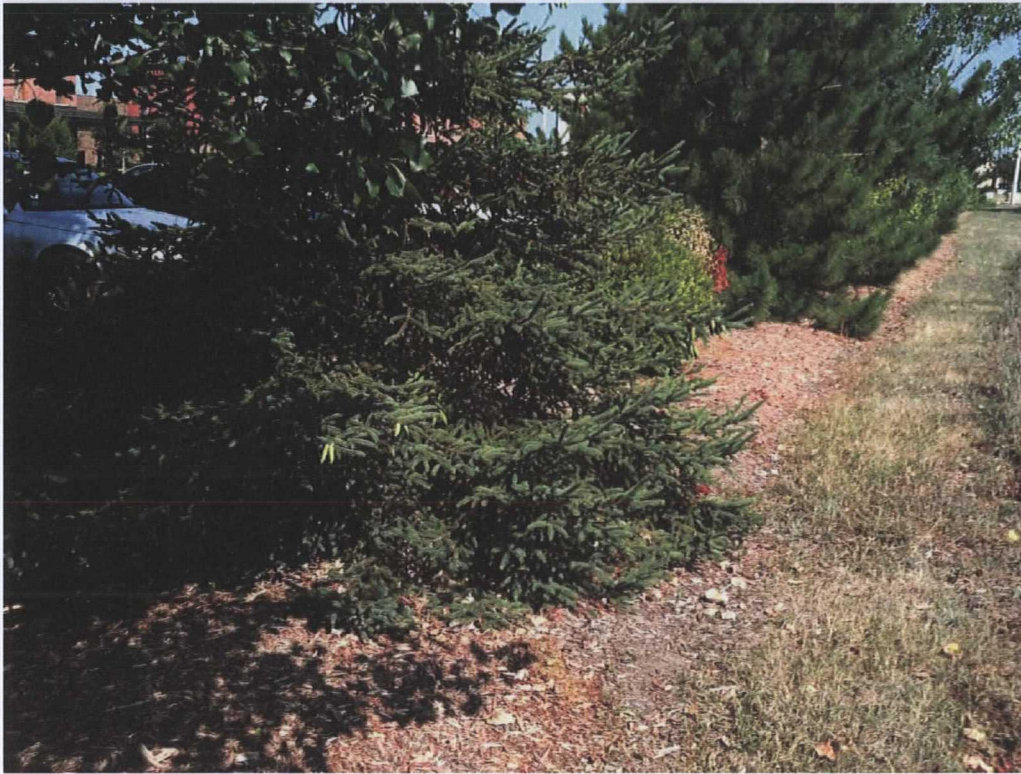
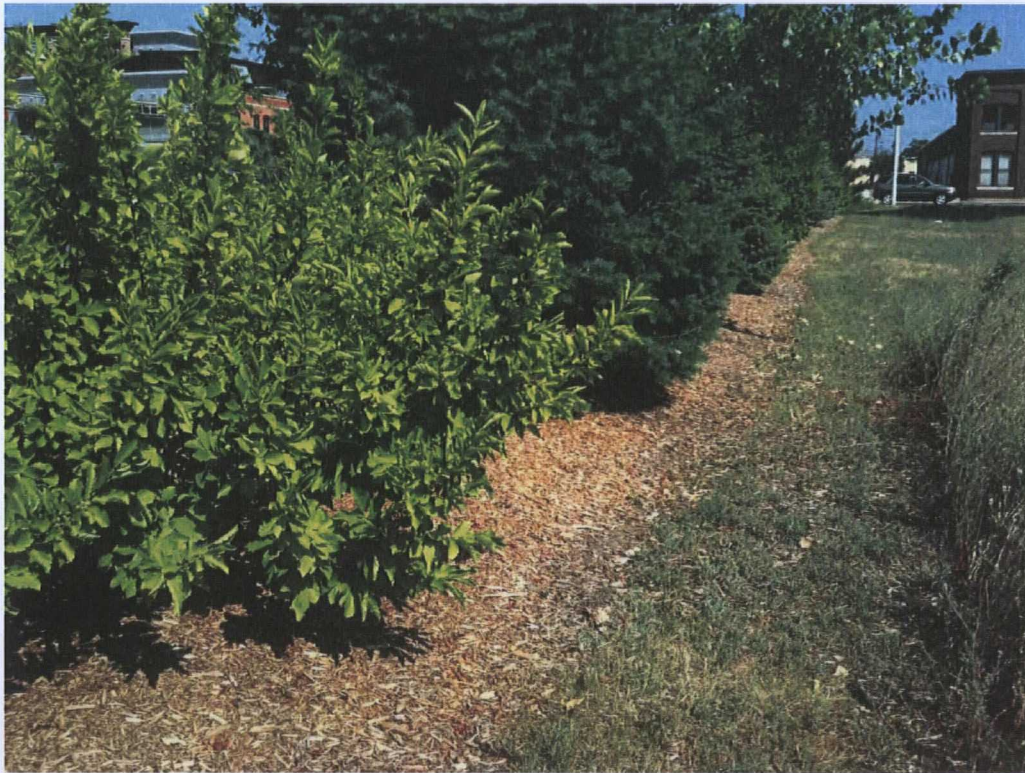
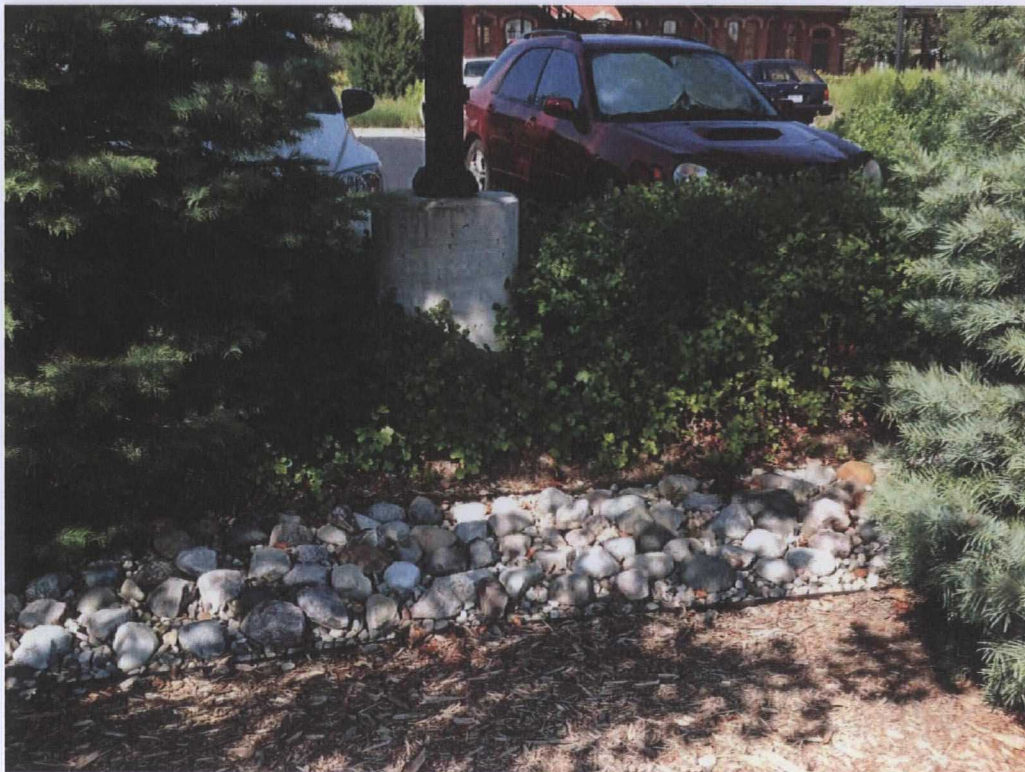
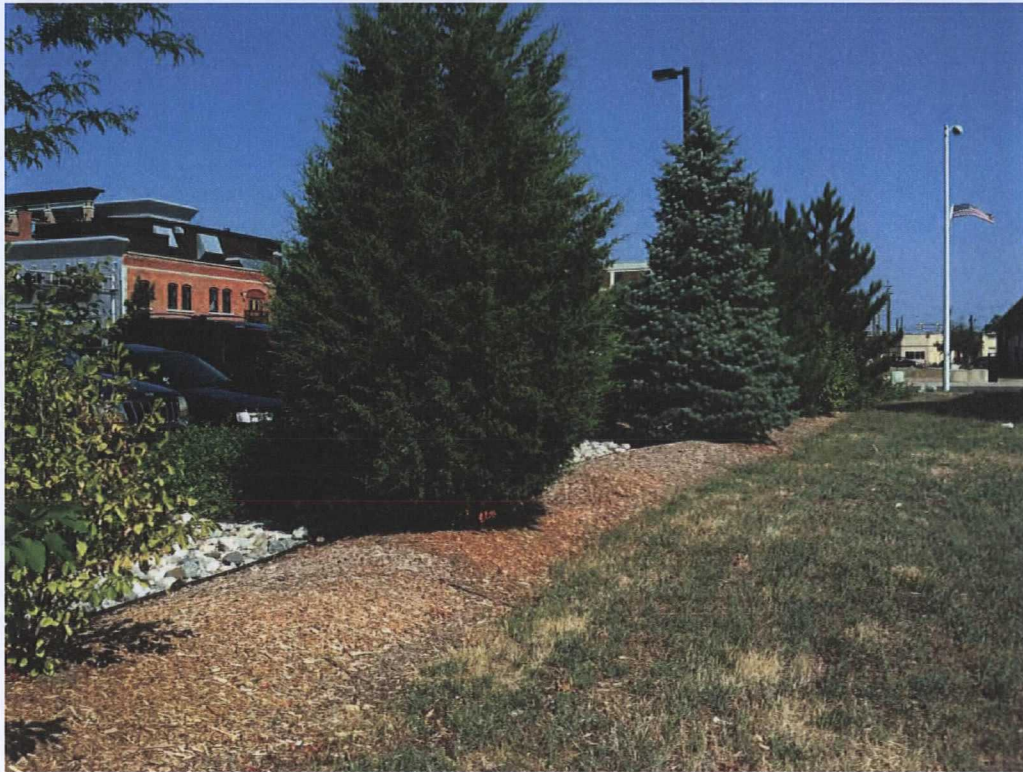
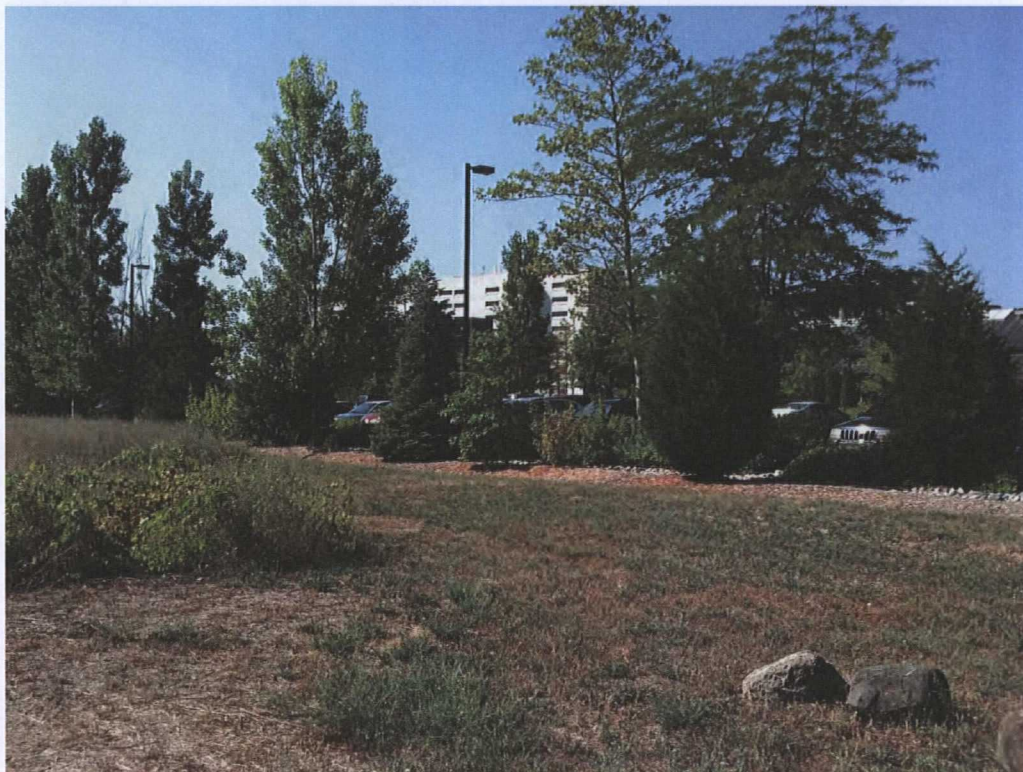
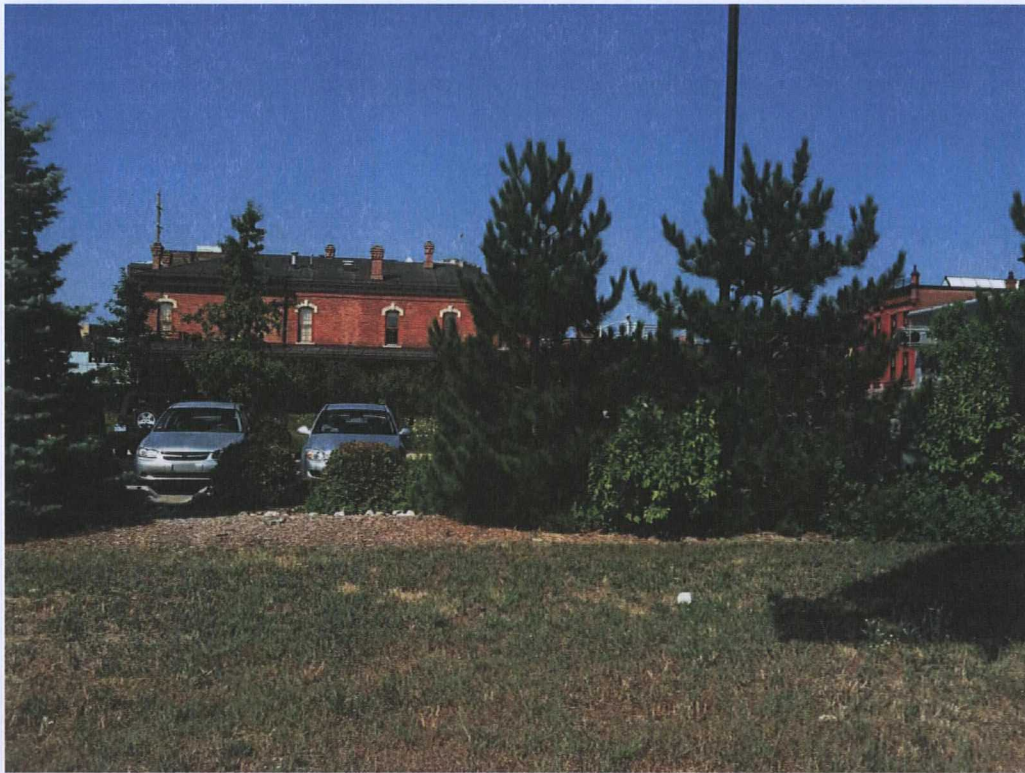
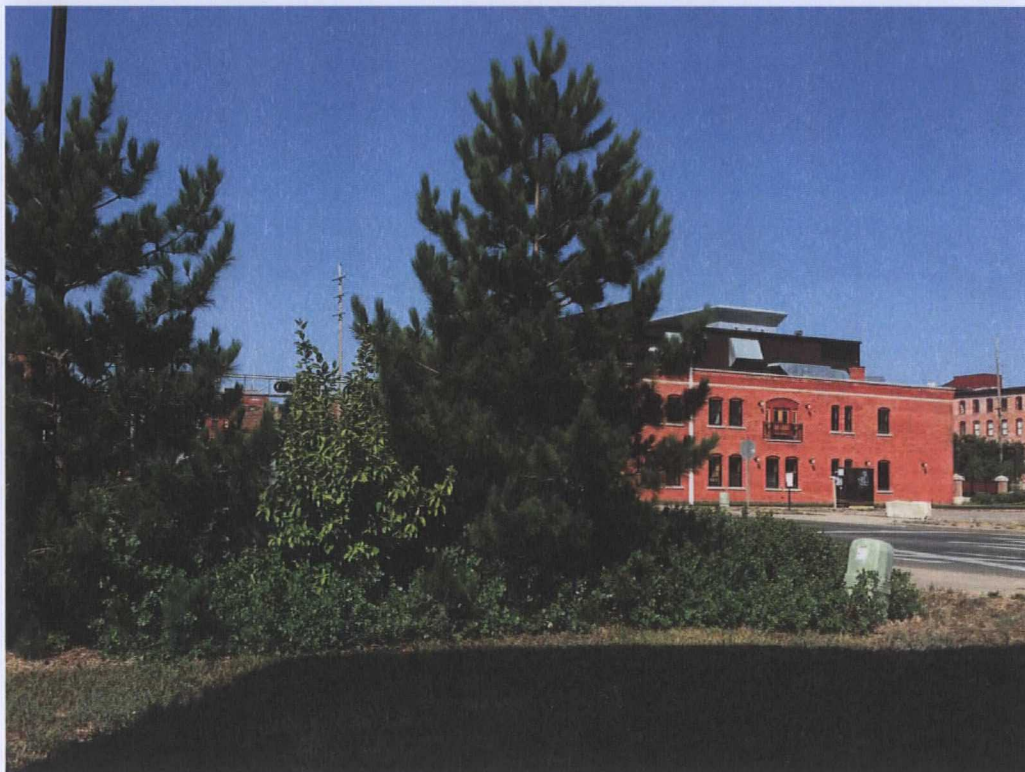
Designation: SA3-Access-S02

- The parking lot is fairly new and in good condition.

- The parking lot and landscaping should be identified/protected with construction fencing or similar during the work.

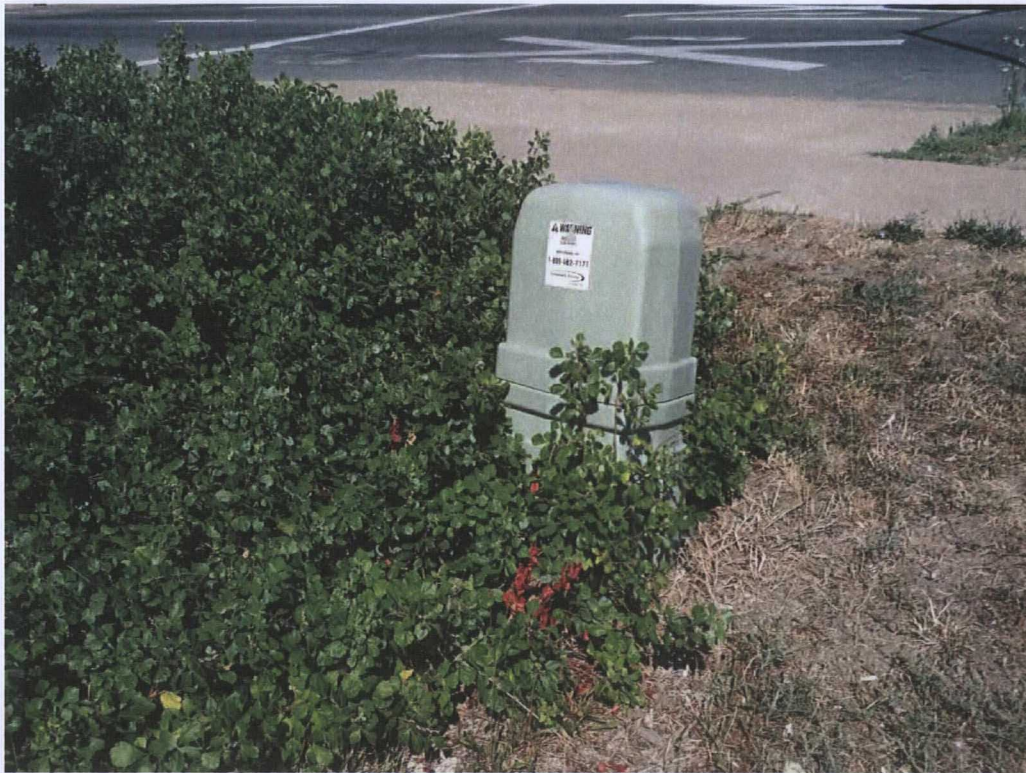
Designation: SA3-Access-S03

- The pedestal appears to be in good condition, however it leans to the north significantly.

View of pedestal looking north toward East Michigan Avenue

- The pedestal should be identified/protected with construction fencing or similar during the work.

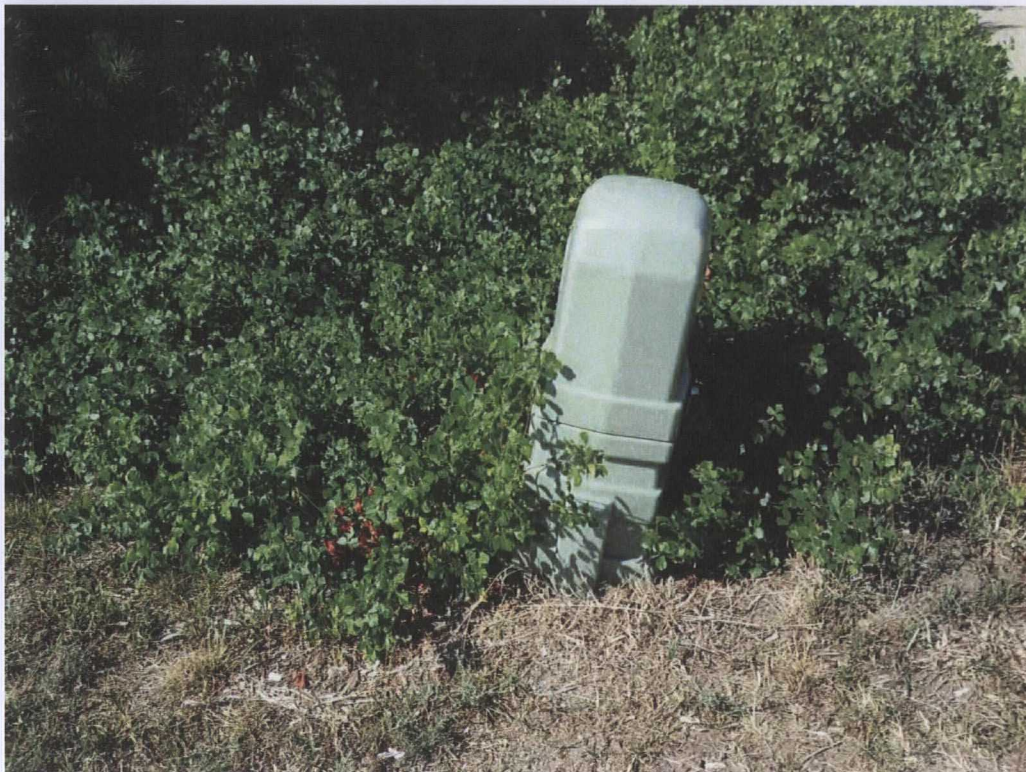
View of pedestal looking west showing northward lean

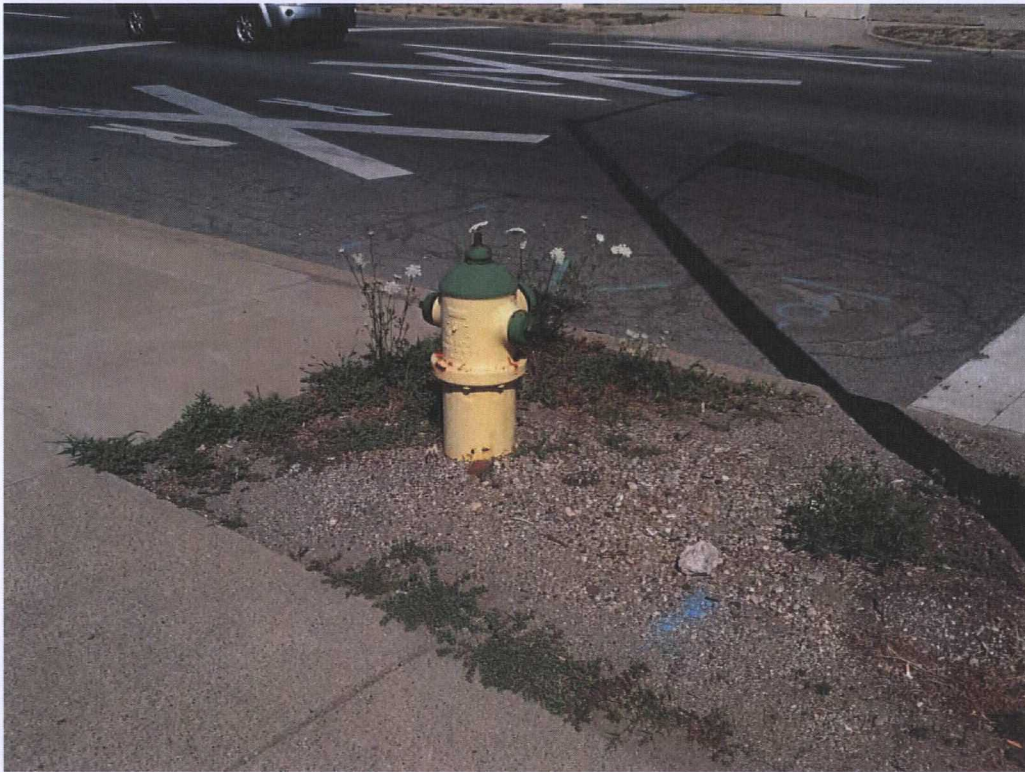
Designation: SA3-Access-S04

- The fire hydrant is in fair condition, with paint flaking and minor surface corrosion.

View of hydrant looking north toward East Michigan Avenue

- The hydrant should be identified/protected with construction fencing or similar during the work.

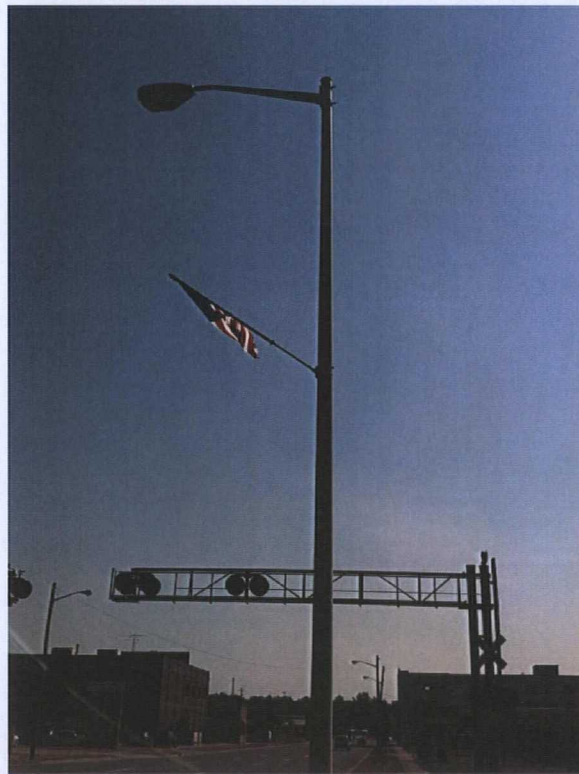
- The pole has minor graffiti but otherwise appears to be in good condition.

View of pole looking east

- The pole should be identified/protected with construction fencing or similar during the work.

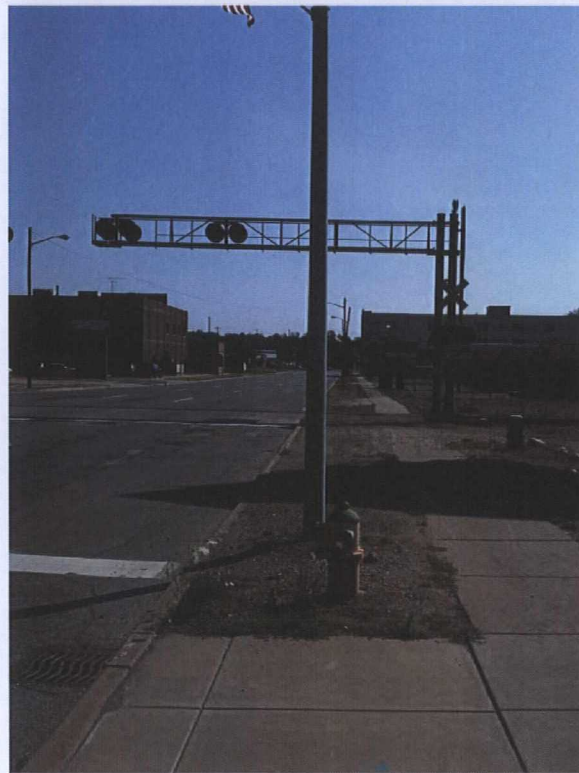
View of pole looking east showing relation to hydrant and east railroad tracks

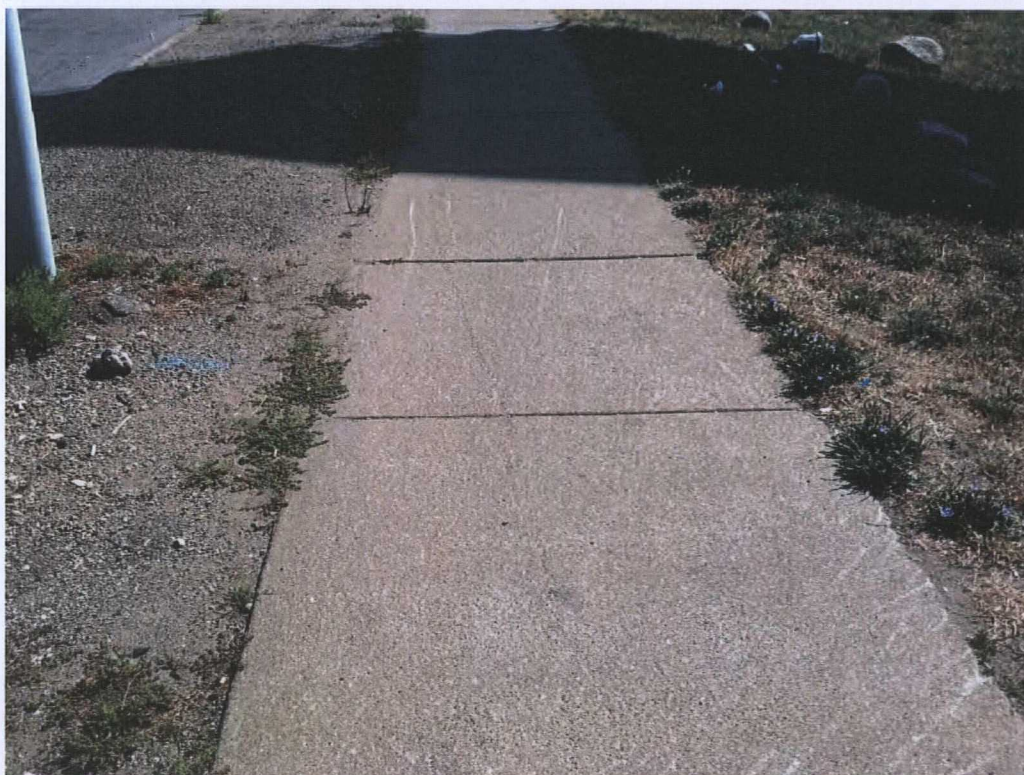
Designation: SA3-Access-S06

- The east flag and 3<sup>rd</sup> from east flag of concrete have moderate cracking.

View of sidewalk looking east

- The existing sidewalk is likely not intended for trucking loads and will likely crack and spall during the work. Damaged sections should be removed and replaced in kind.

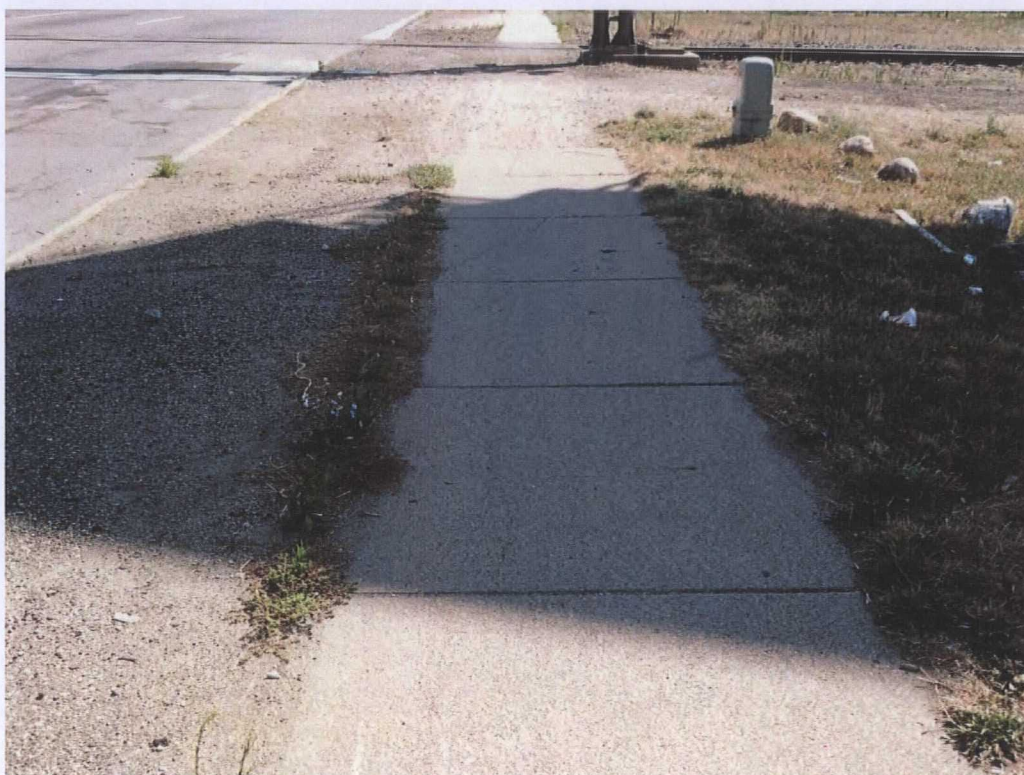
View of sidewalk looking east showing relation to hydrant and east railroad tracks

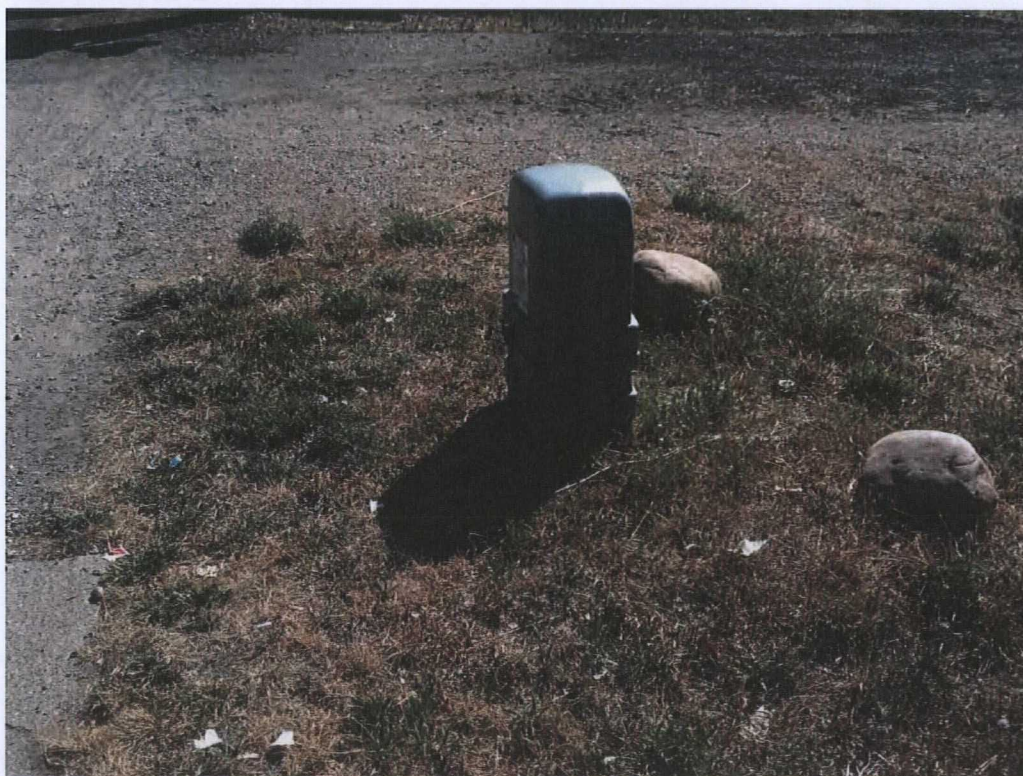
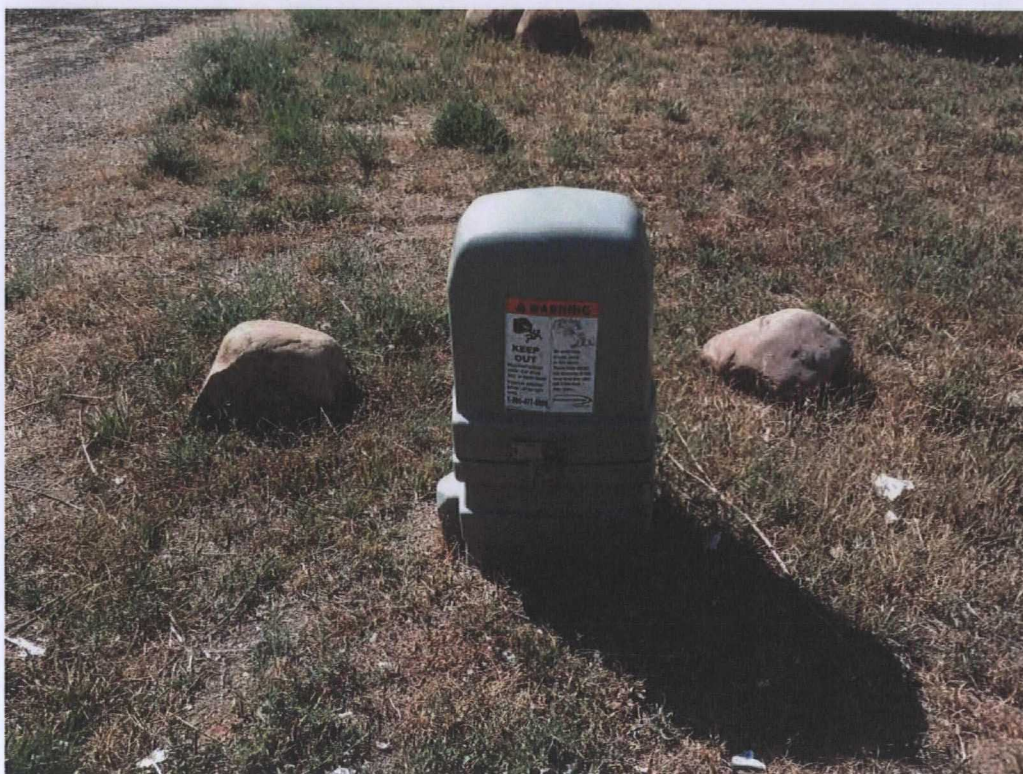
- The pedestal appears to be in good condition.

View of the pedestal looking east

View of the pedestal looking south

- The pedestal should be identified/protected with construction fencing or similar during the work.

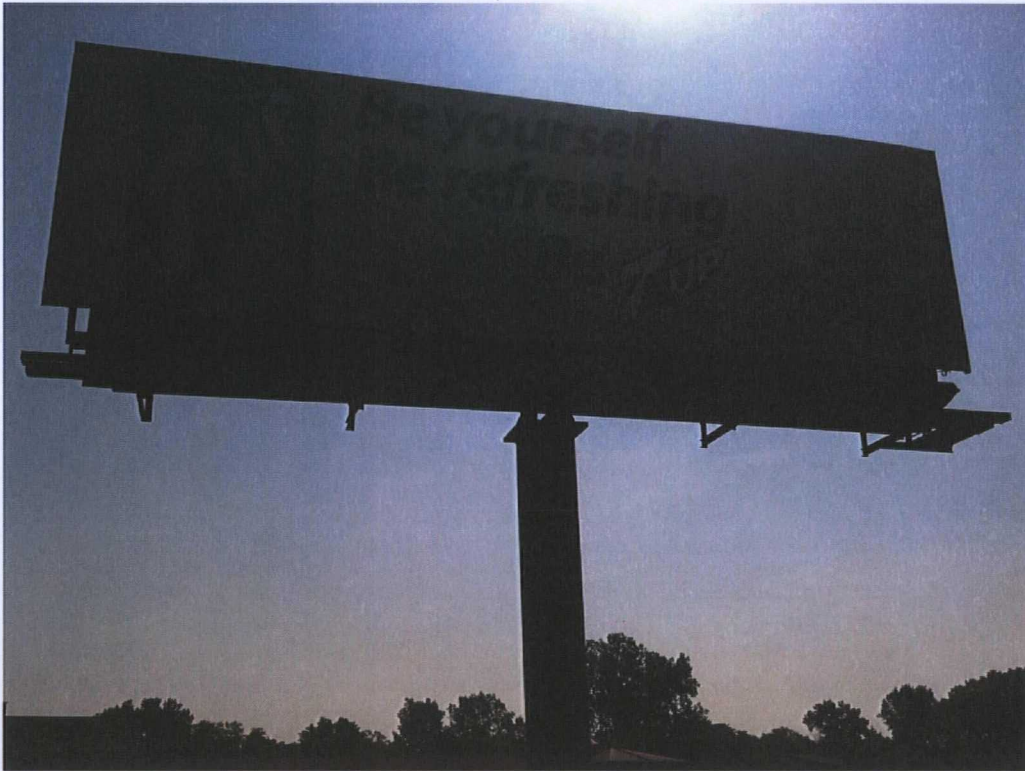
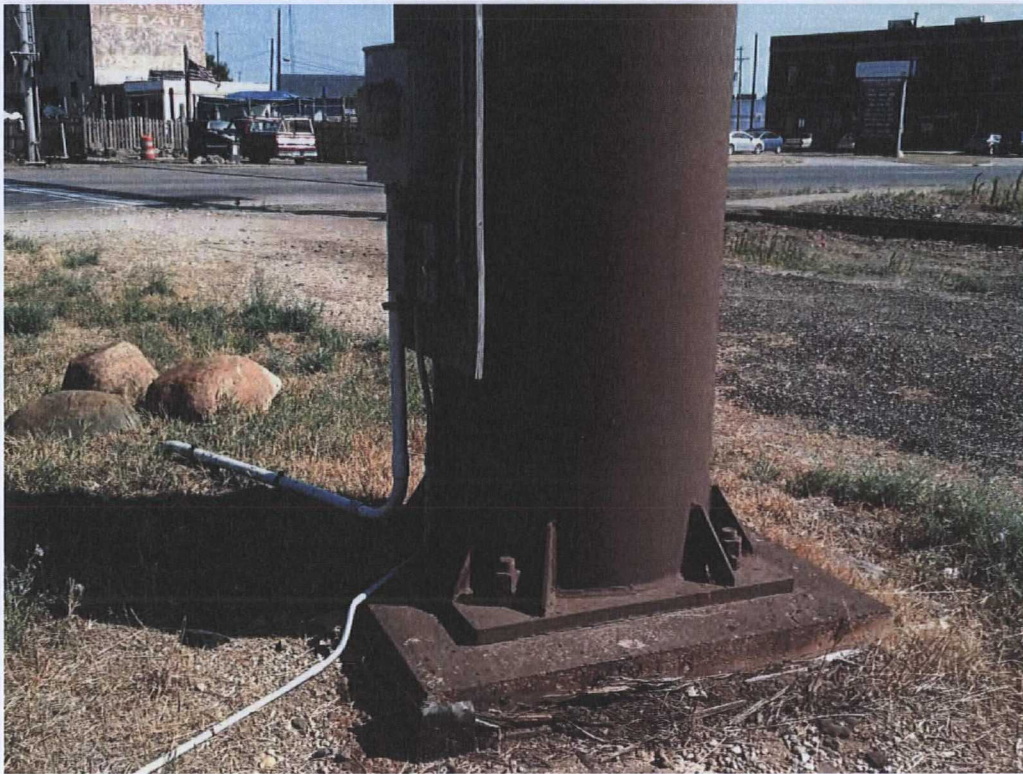
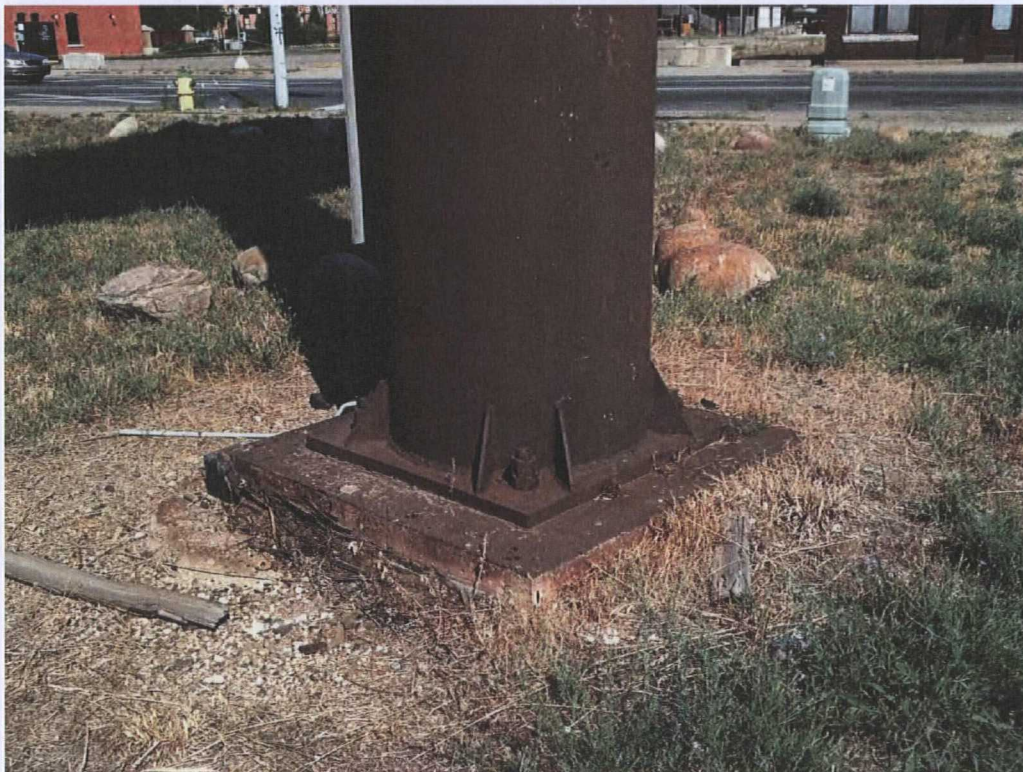
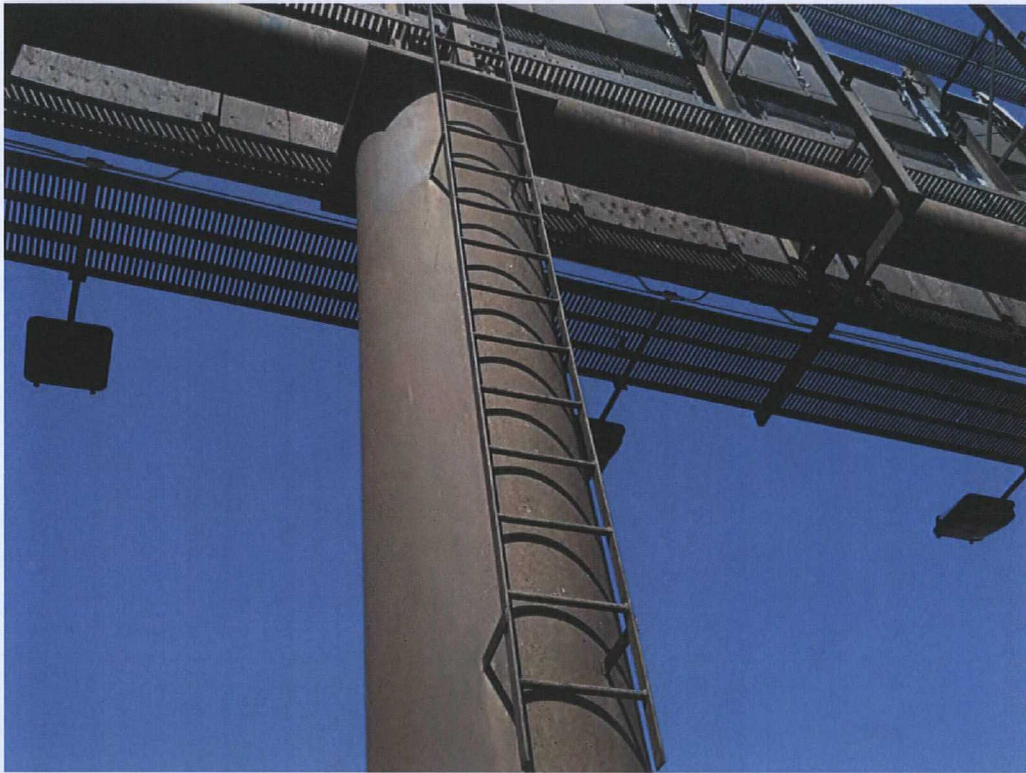
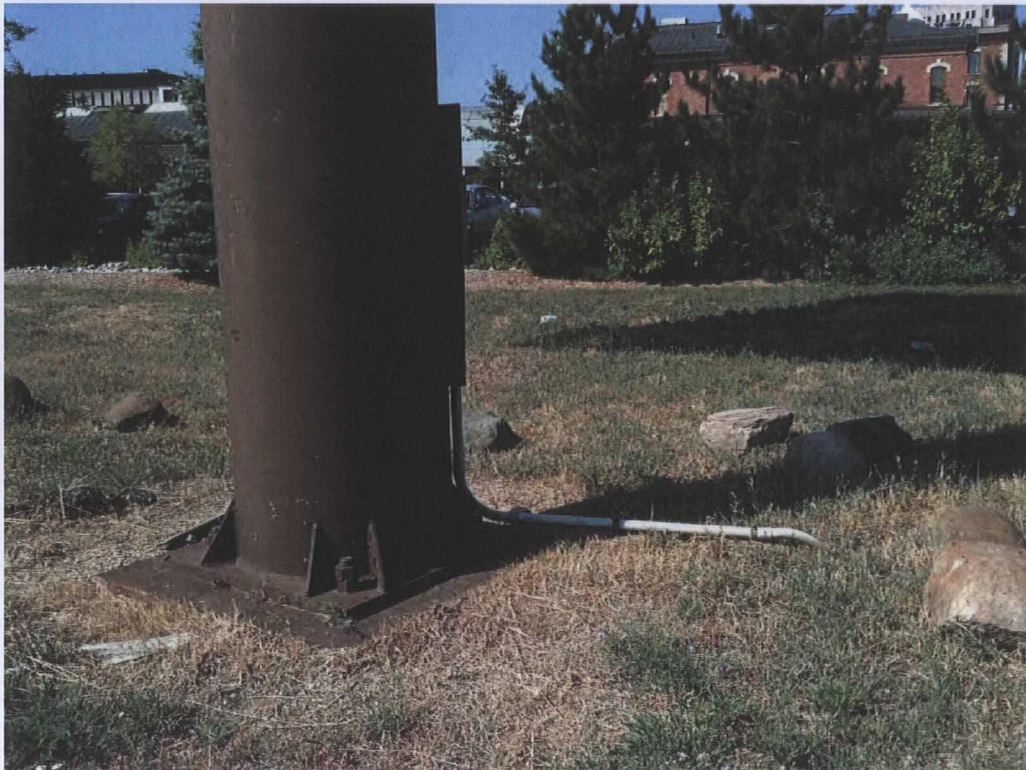
- The steel column has minor scrapes and flaking paint.
- There is an electric service panel on the west side mounted on a timber panel. One of the box covers is loose.
- The electric conduit extending to the southwest is loose.
- The grounding rod is exposed and loose.
- The exposed concrete pedestal has hairline cracking and isolated spalling.

- The billboard structure should be identified/protected with construction fencing or similar during the work.

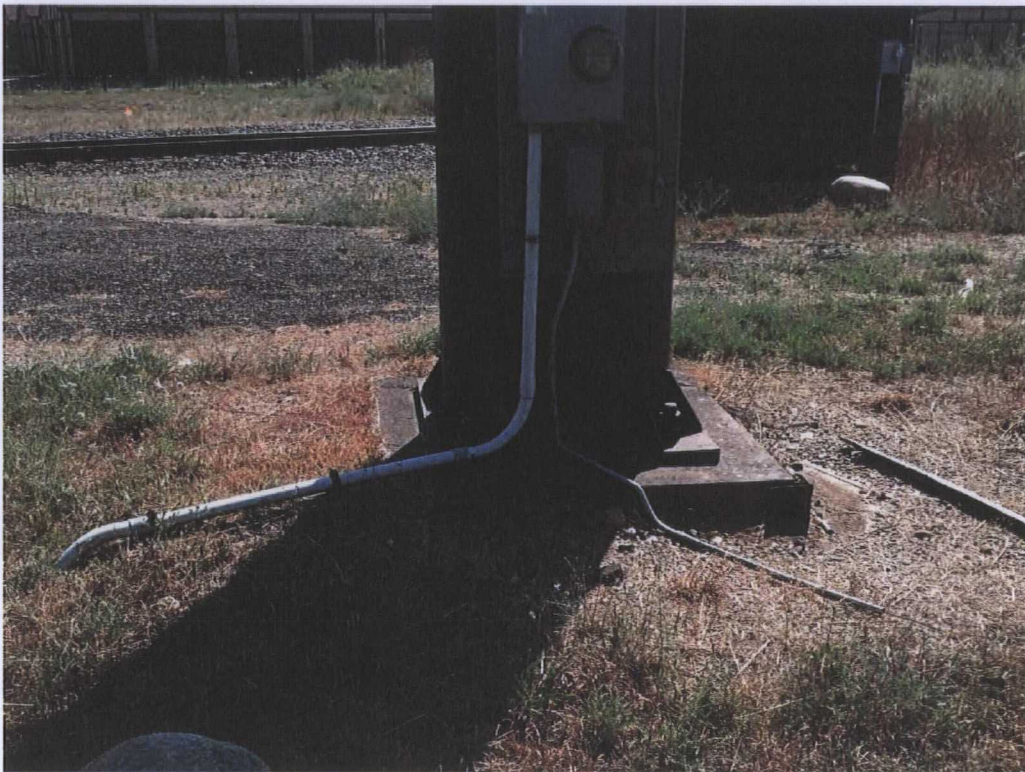
Conduit and service panel on west side of billboard

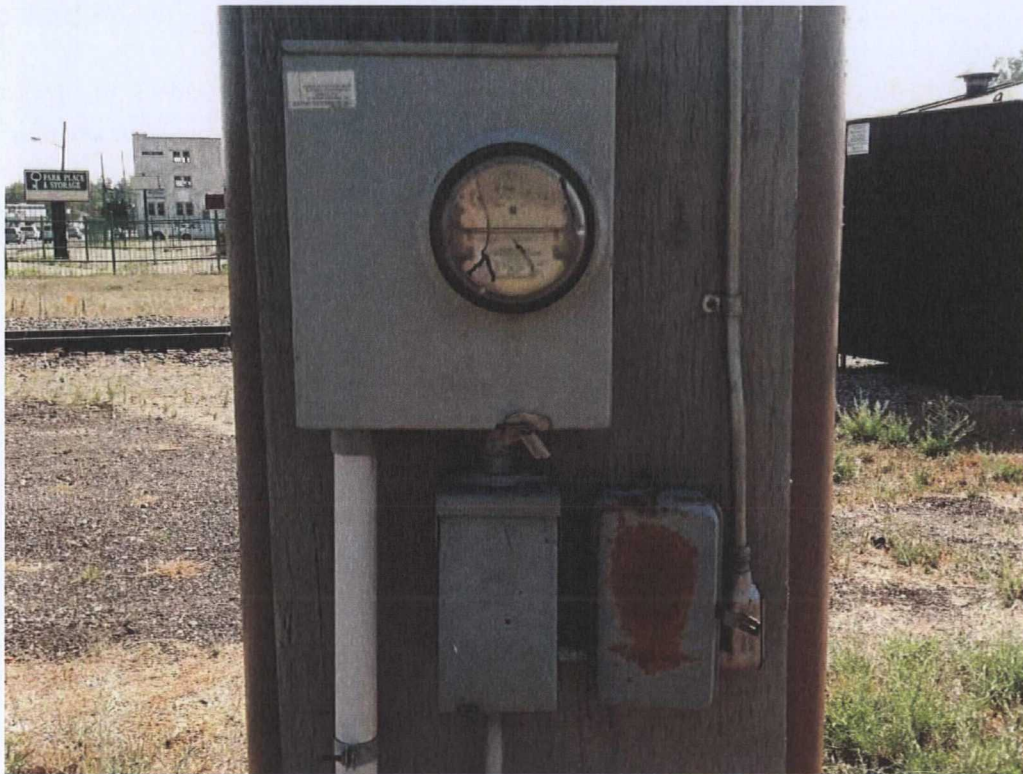
Close-up view of service panel
